California Avenue Bridge Over the Chicago Sanitary and Ship Canal ****

Appendix G: BRIDGE INSPECTION REPORT

Structure No. 016-6005

Inspection Date: August 3, 2022

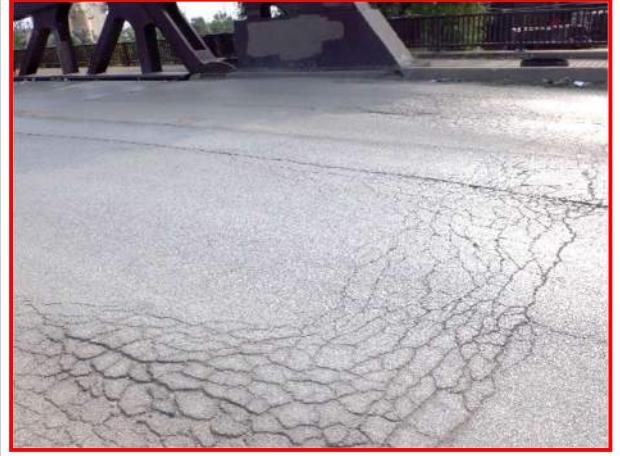
- Fixed spans, the bituminous wearing surface exhibits a few wide full width transverse and full-length longitudinal cracks.
- Span 1, there is heavy wide alligator cracking above the North Counterweight Pit backwall and along the southbound lane, and rutting in the southbound lane inside wheel line (see Photograph 3).
- Span 3, there is a 2 SF steel repair plate in the southbound lane and a 3 SF spall filled with bituminous material along the centerline of roadway (see Photograph 4).
- Span 4, there is a 4 SF pothole filled with bituminous material in the southbound lane.
- Pavement markings are not visible on the structure.

3. Span 1, wearing surface, looking southwest.

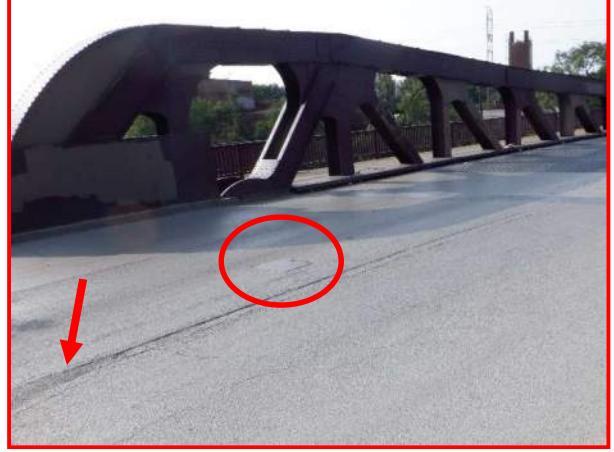
4. Span 3, wearing surface, looking northwest.

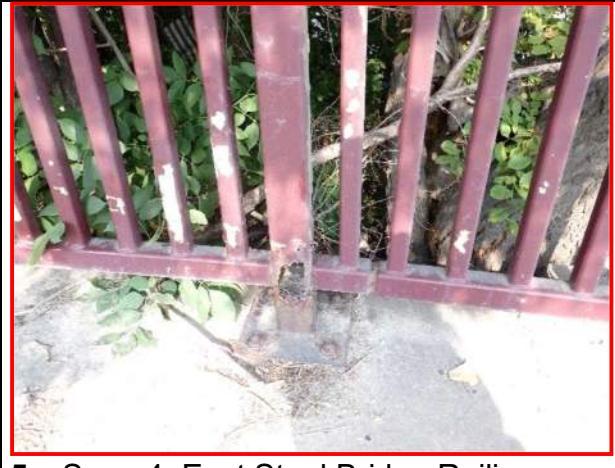
5. Span 4, East Steel Bridge Railing, looking down and east.

- The steel bridge railings in the Movable Span exhibit isolated areas of minor paint peeling and there is a 2-inch horizontal misalignment in the west railing at the center break.
- The Fixed Span steel bridge railings exhibit scattered paint peeling, minor corrosion at the base of a few railing posts in the southeast quadrant, and one approximately 9-square inch corrosion hole at the base of the east steel bridge railing post immediately north of the south expansion joint (see Photograph 5).

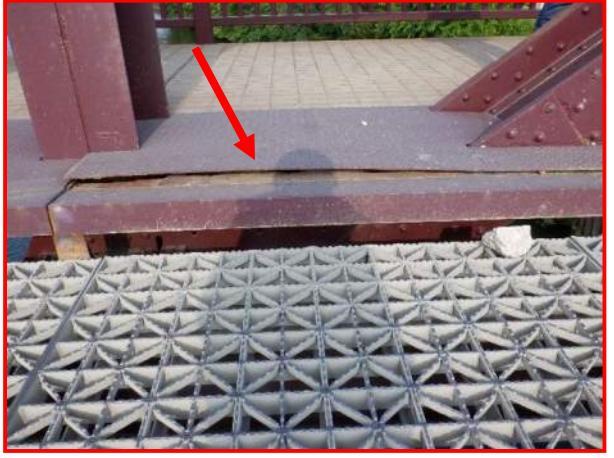
Movable Span, cover plate, looking east.

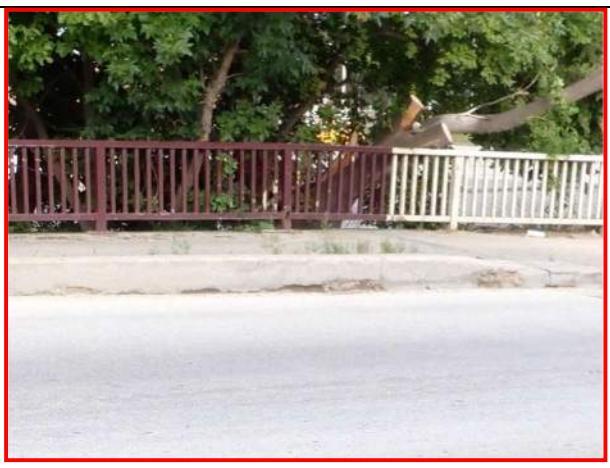
- Movable Span, the steel plate curbs exhibit minor paint peeling scattered throughout.
- Movable Span, the underside of the cover plate spanning the truss gap typically exhibits minor to moderate pack rust and minor corrosion along the joint with the curb angle (see Photograph 6); the top of the cover plates exhibit paint peeling with minor corrosion and there are a few loose plates in the South Leaf.
- The concrete curbs in the fixed spans exhibit scattered narrow vertical and horizontal cracks and minor edge spalls.
- In Span 1, there is an approximately 2-foot long spall with exposed corroded reinforcement in the West Curb.
- Span 4, the east curb exhibits a 7-foot section of hairline map cracking on the vertical and top faces and spalling along the bottom edge for almost the entire length (see Photograph 7).

7. Span 4, East Curb, looking east.

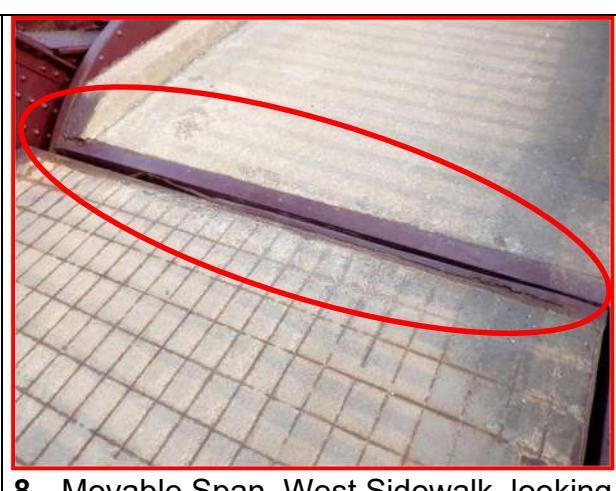
- The sidewalks in the Movable Span typically exhibits minor surface corrosion of the exposed steel grating and scattered areas of minor spalling.
- Movable Span, along the rear break of the South Leaf west sidewalk, the edge plate is detached for most of the sidewalk width (see Photograph 8).
- The underside of the Movable Span sidewalks exhibit minor to moderate corrosion of the steel pans, primarily along the outer 2 feet and inside 1 foot, and there are some instances of corrosion holes in the pans.

8. Movable Span, West Sidewalk, looking down and south.

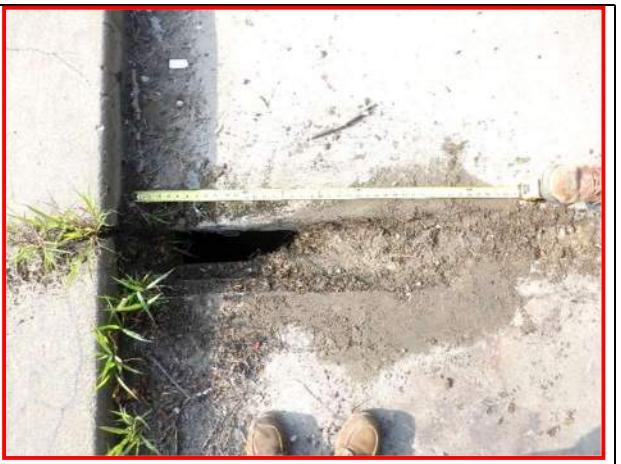
- The Fixed Span sidewalks exhibit scattered light scaling and debris along the edges.
- Span 3, the east sidewalk at the south counterweight pit back wall has an approximately 3-foot length of missing joint filler adjacent to the bridge railing and a 5-inch by 16-inch through hole adjacent to the curb (see Photograph 9).
- Span 4, there is a 3 SF spall in the edge of the west sidewalk near the south counterweight pit back wall (see Photograph 10).
- The underside of the sidewalks in the Fixed Spans exhibit a few scattered hairline diagonal and transverse cracks, areas of delamination up to 2 SF, and spalls up to 2 SF with corrosion staining at the embedded steel plates in Span 4.
- The navigation light platform hatches near the Center Break are all unsecured.
- The northeast approach sidewalk has a vertical settlement of up to 1-inch.

9. Span 3, East Sidewalk, looking down.

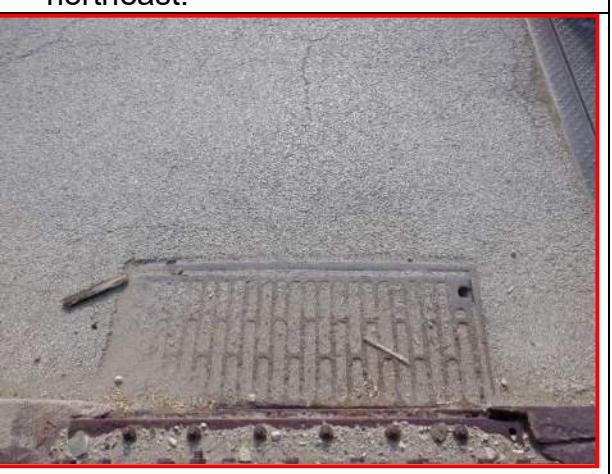
• The deck drains in Spans 1 and 3 are fully clogged (see Photograph 11).

11. Span 3, east deck drain, looking down.

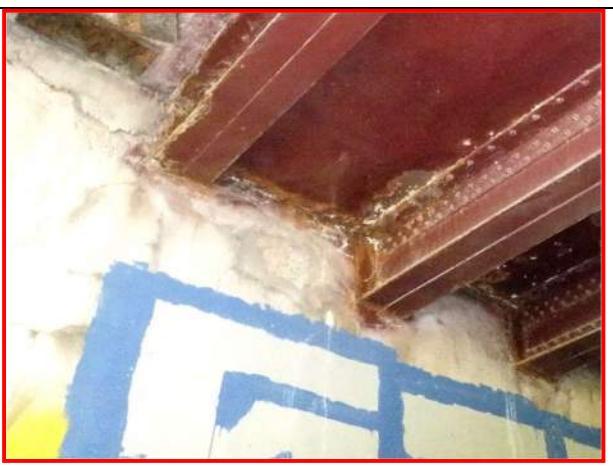
- The buckle plates along the deck soffit in Span 4 exhibit minor to moderate corrosion over the South Abutment at the cut sections and there are isolated areas of corrosion holes along the counterweight pit backwall (see Photograph 15).
- Movable Span, there is a 6-inch strip of exposed concrete along the full width at the edges of the concrete filled sections and the deck panels have scattered areas of minor surface corrosion (see Photograph 16).

15. Span 4, deck soffit, looking up and north.

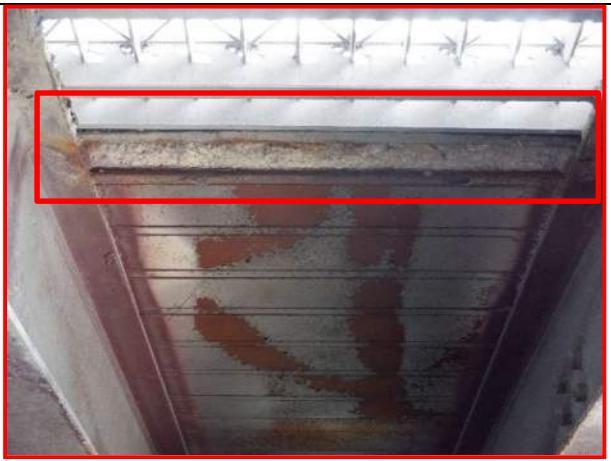
16. Movable Span, deck soffit, looking south.

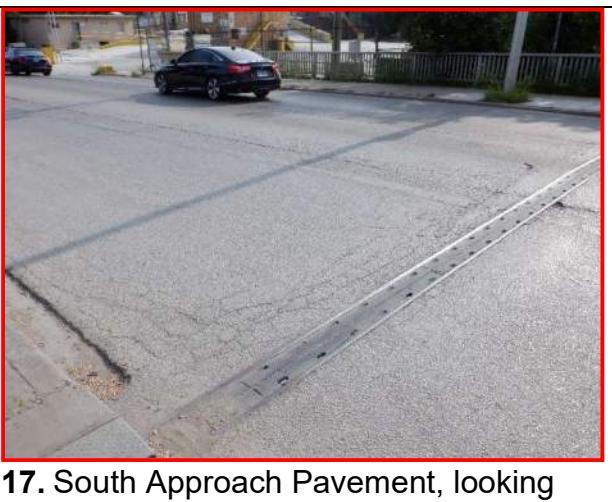
The approach pavements exhibit wide alligator cracking along the South Expansion Joint and above the backwall of the North Counterweight Pit, wide longitudinal cracks along the centerline of the roadway and along the centerline of each lane (see Photograph 17).

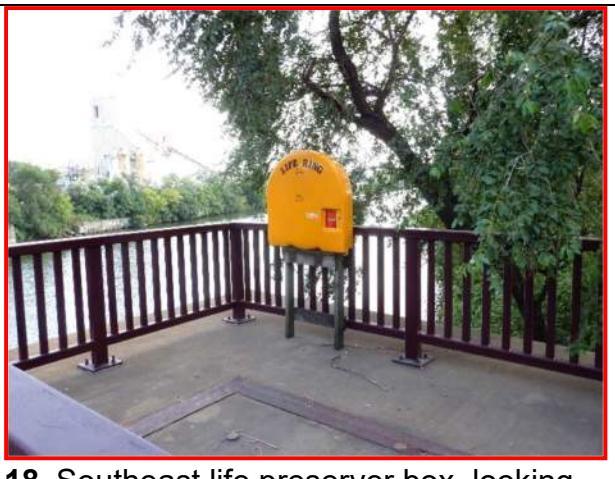
- Life preservers are in place at the northwest and southeast corners of the bridge and there is minor graffiti on the southeast live preserver box (see Photograph 18).
- The railings along the stairs in the southeast corner of the structure are missing most of the railing spindles (see Photograph 19).
- There is vegetation encroachment over both sidewalks in Span 4.

18. Southeast life preserver box, looking northeast.

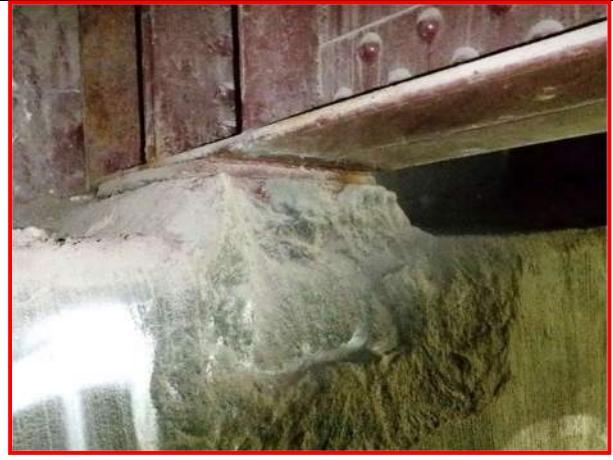
- The bearings that support the roadway stringers at the backwall of the counterweight pit in Spans 1 and 3 are inaccessible for inspection due to the position of the counterweight.
- The sidewalk stringer bearings in the fixed spans typically exhibit minor to moderate corrosion; Span 1, the west sidewalk stringer bearing exhibits moderate corrosion with moderate section loss and approximately 15% bearing area loss (see Photograph 22).
- The bearings on the South Abutment exhibit minor corrosion and the elastomers are slightly deformed out-of-plane; Stringer 2 and Stringer 5 exhibit 2-inches of bearing area loss along the full width at the face of the abutment (see Photograph 23).

23. Span 4, Stringer 5 bearing, looking southwest.

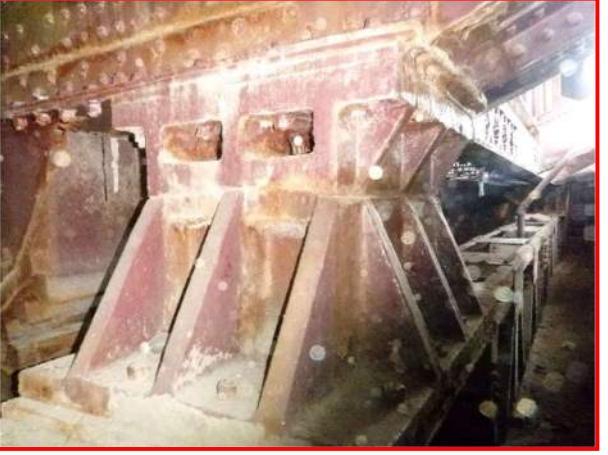
- The live load bearings exhibit minor surface corrosion with minor pitting (see Photograph 24).
- The trunnion bearings typically exhibit minor pitting that has been painted over (see Photograph 25).
- The secondary live load bearings exhibit moderate to heavy corrosion with minor pitting and pack rust between the strike plates (see Photograph 26). There is no gap at any of these bearings.

24. Northwest live load bearing, looking east.

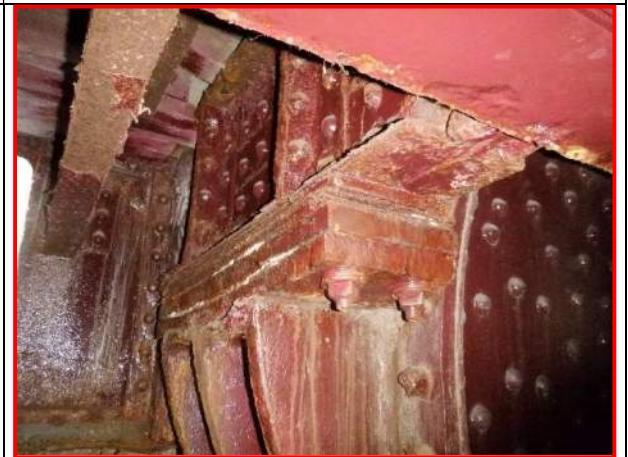
26. Southeast Secondary Live Load Bearing, looking west.

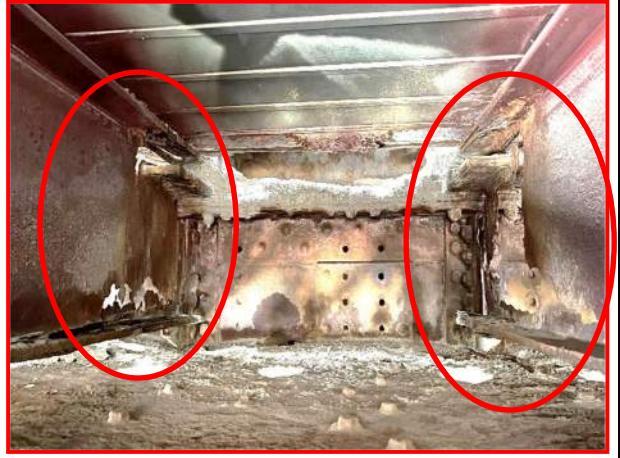
- Movable Span, a majority of the roadway stringer ends over Floorbeam 16-16 at the rear breaks exhibit heavy corrosion with full height section loss and/or a vertical crack in the web that emanate from the longitudinal plate welded to the web (see Photographs 27 & 28). For additional details, see Exhibit 2 included at the end of this report.

27. Movable Span, south roadway stringer end, looking south.

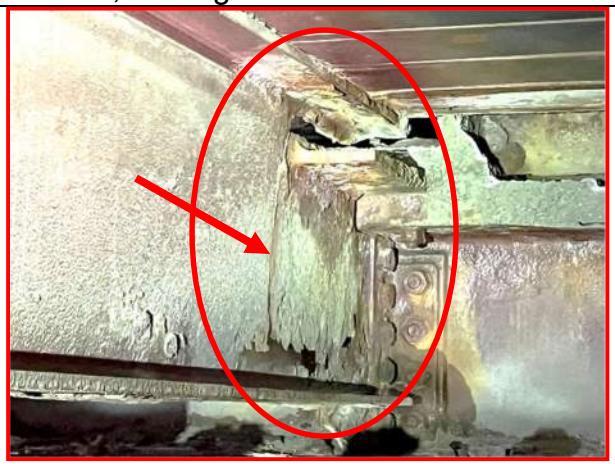
28. Movable Span, north roadway stringer end, looking north.

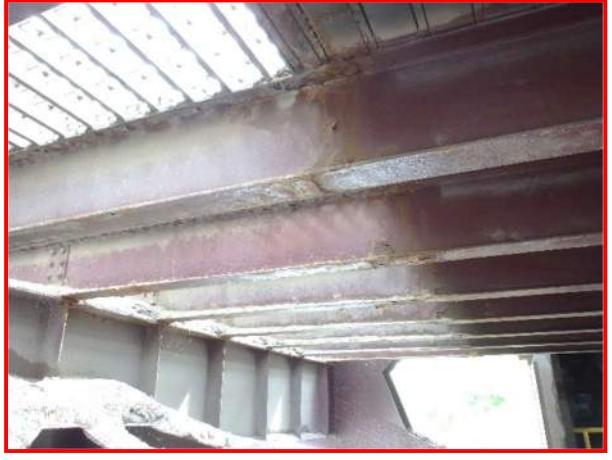
- The roadway stringers in the movable span typically exhibit isolated areas of minor corrosion, minor to moderate pitting along the bottom of the web and bottom flange that has been painted over, with isolated areas of corrosion holes up to 2-inches in diameter, and there is isolated moderate section loss along the height of the web at the splice plates above the floorbeams (see Photographs 29).

29. Movable Span, Panel 1 roadway stringers, looking southwest.

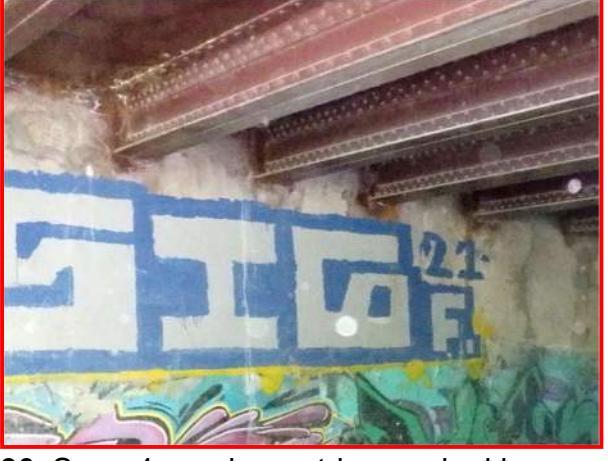
- Span 4, the roadway stringers exhibit minor to moderate corrosion at the back face of the counterweight pit backwall and minor corrosion at the stringer ends above the abutment (see Photograph 30).
- The sidewalk stringers in the movable span and fixed spans have no defects.

30. Span 4, roadway stringers, looking northeast.

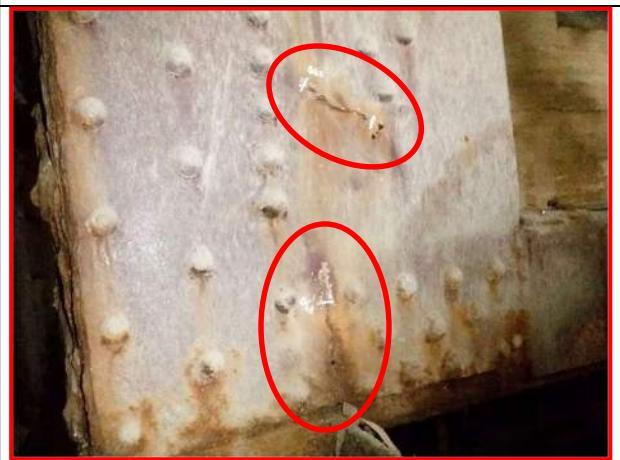
- South Trunnion Girder, in the northeast lower gusset plate there is a 6.5-inch vertical crack between the end of the bottom chord and the edge of the trunnion post, and a 5.25-inch diagonal crack with a ³/₄-inch corrosion hole immediately adjacent at the end of the diagonal member; the portion of the plate above the diagonal crack is slightly out of plane to the north (see Photograph 31).
- South Trunnion Girder, in the middle third of the bottom chord there are several small diameter corrosion holes along the bottom of the north web (see Photograph 32).
- South Trunnion Girder, the lower south gusset plates exhibit signs of moderate pack rust and are up to approximately ½-inch out-of-plane along the top of the bottom chord.
- North Trunnion Girder, the southwest lower gusset plate has a 4-inch diameter corrosion hole at the end of the diagonal member.

31.South Trunnion Girder, northeast lower gusset plate, looking south.

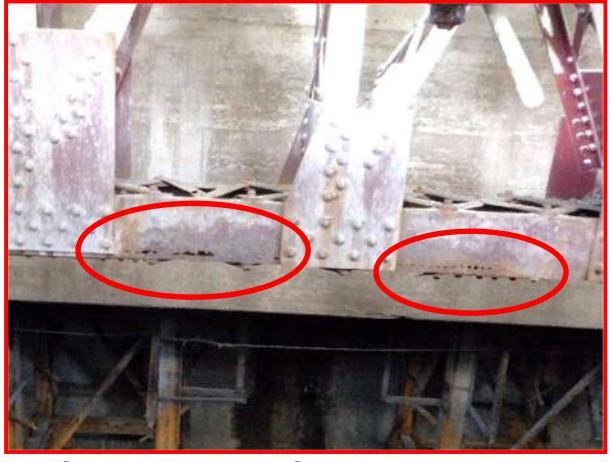
32. South Trunnion Girder, bottom chord, looking south.

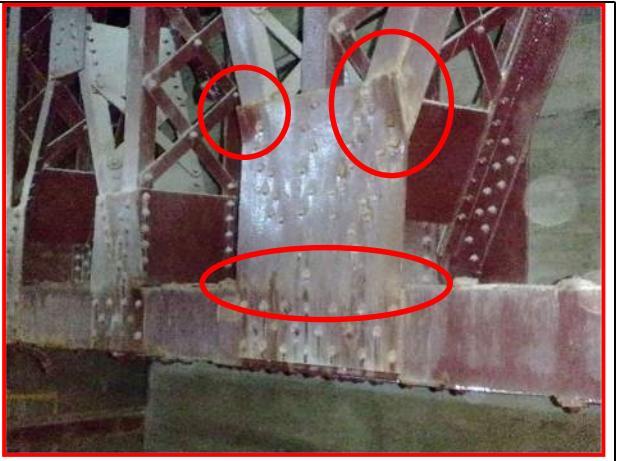
North Trunnion Girder, the two east interior gusset plates along both faces exhibit signs of moderate pack rust and are up to approximately ½-inch out-of-plane along the top of the bottom chord (see Photograph 33); the south lower gusset plate below Stringer 4 has a corrosion hole at the east edge along the top of the bottom chord (see Photograph 34).

33. North Trunnion Girder, south gusset plates, looking northwest.

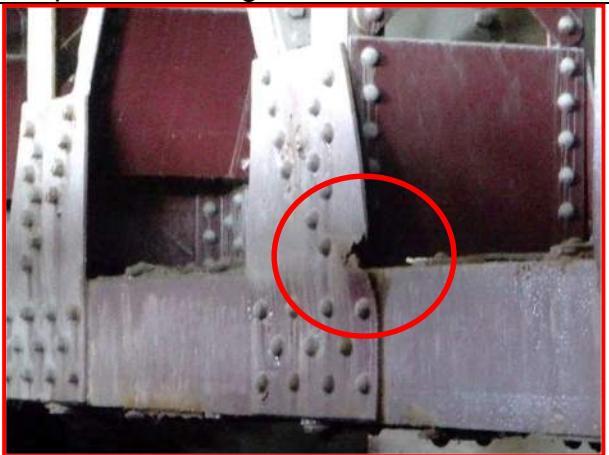
34.North Trunnion Girder, south gusset plate, looking northwest.

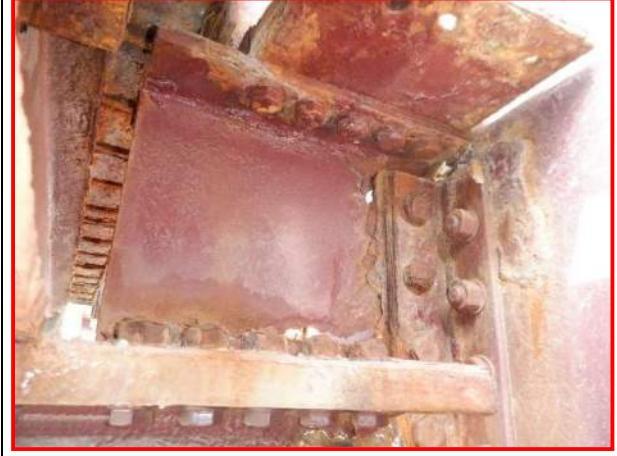
35. Floorbeam 0-0N, looking north.

- The floorbeams in the movable span typically exhibit minor to moderate pitting that has been painted over primarily along the bottom of the bottom flanges and along the height of the web at the end connections, with areas of moderate to heavy debris accumulations along both flanges below the open grid deck.
- Floorbeam 0-0N, at the east end there is minor to moderate corrosion and section loss along the height of the web and the strap bar connection beam above the top flange has full section loss around the perimeter (see Photograph 35).

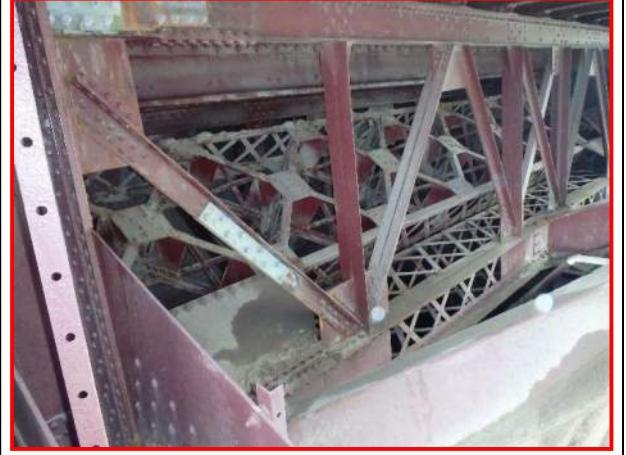
- Floorbeam 12-12N and 12-12S have isolated corrosion holes up to 3-inches in diameter in the diagonal members and bottom chord and there are repair plates at several top chord end connections and along some diagonals (see Photographs 36); the strap bar connection plates exhibit section loss up to 3-inches wide by 15-inches long.

36. Floorbeam 12-12N, looking northeast.

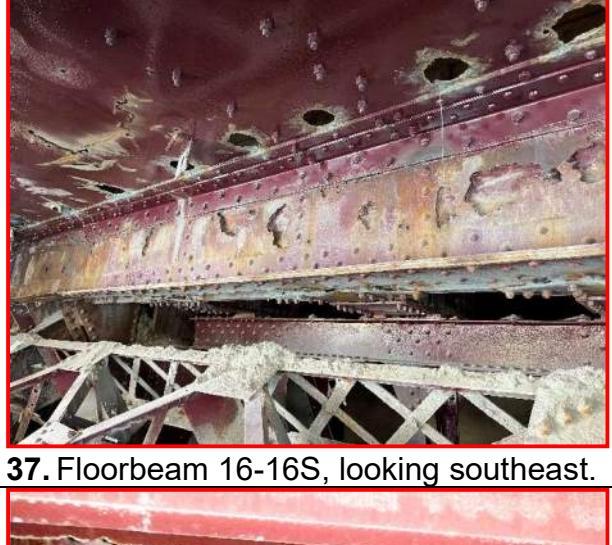
- Floorbeam 16-16S exhibits full height moderate to heavy corrosion with several corrosion holes in the east half of the original web; there is a repair plate welded to the south face of the web (see Photograph 37).

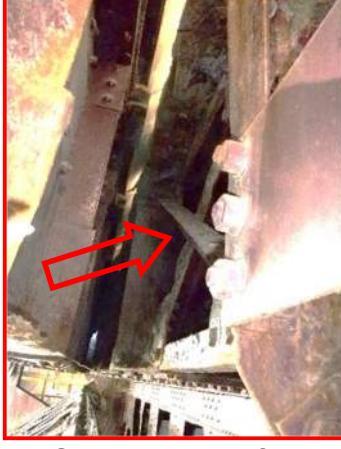
• Spans 1 and 3, the cross frames above the trunnion girders exhibit moderate to heavy corrosion.

39. Span 3, cross frame, looking southeast.

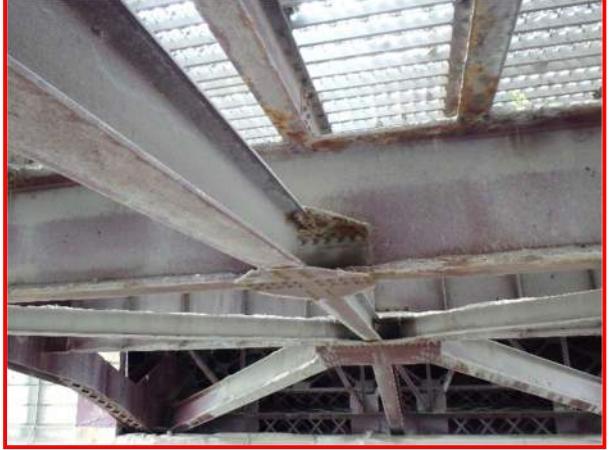
- Movable span, the roadway framing lateral bracing exhibits minor pitting that has been painted over and minor section loss along the bottom of the bottom flanges, with areas of debris accumulations along the flanges (see Photograph 40).
- Movable span, the sidewalk stringer lateral bracing has no noted defects.
- The trusses bracing the live load bearings exhibit minor corrosion with isolated areas of heavy corrosion with corrosion holes up to 16"x3" (see Photograph 41).
- The lattice trusses have numerous areas of corrosion holes up to 3-inches in diameter and moderate to heavy section loss of the connection plates and lacing bars (see Photographs 42).

40. Movable Span, lateral bracing, looking south.

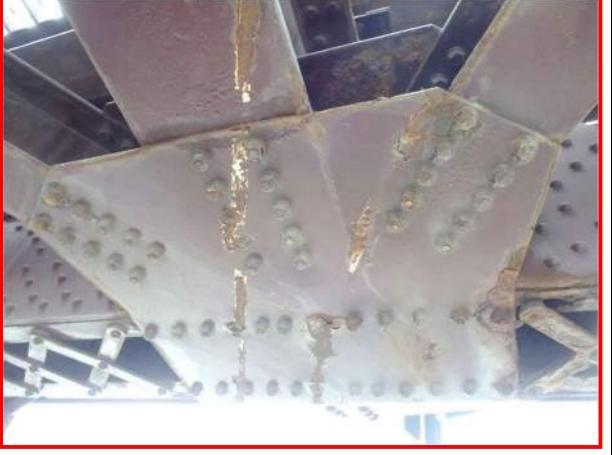
- PP4SW has scrape marks with 5 sheared bolts in the lateral gusset plate (see Photograph 43).
- There are a few locations with missing bolts in the lateral gusset plates.

43.PP4SW lateral gusset plate, looking up.

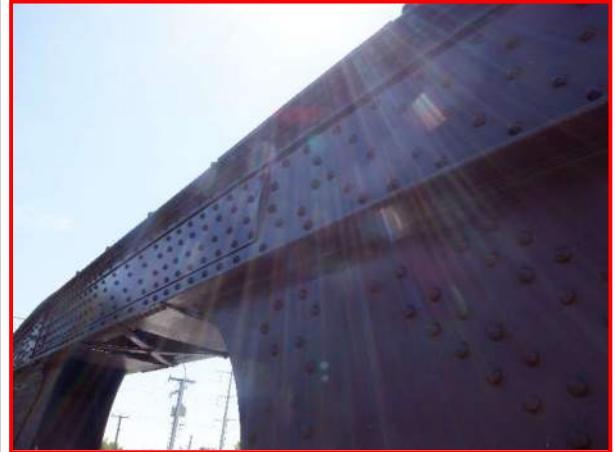
- Top chord members exhibit minor to moderate pack rust in isolated locations between web plates and between flanges and batten plates (see Photograph 44).

44. Top Chord 13-15SE, looking southwest.

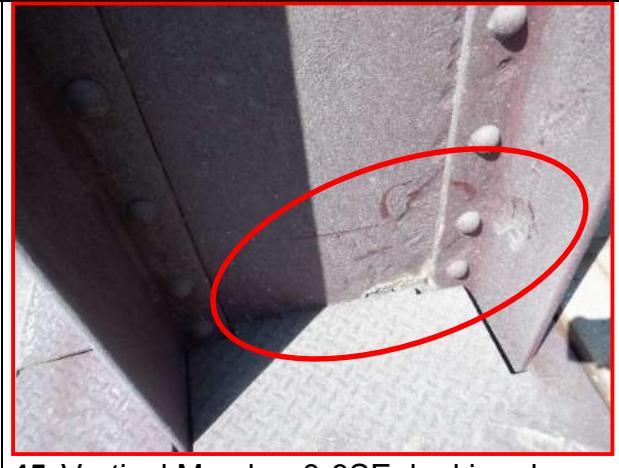
- The diagonal and vertical members typically exhibit minor pitting that has been painted over, with a few corrosion holes up to 3-inches in diameter in the web at the roadway level, and moderate pack rust in diagonal members between the flange angles and flange cover plates (see Photograph 45).

45. Vertical Member 8-9SE, looking down.

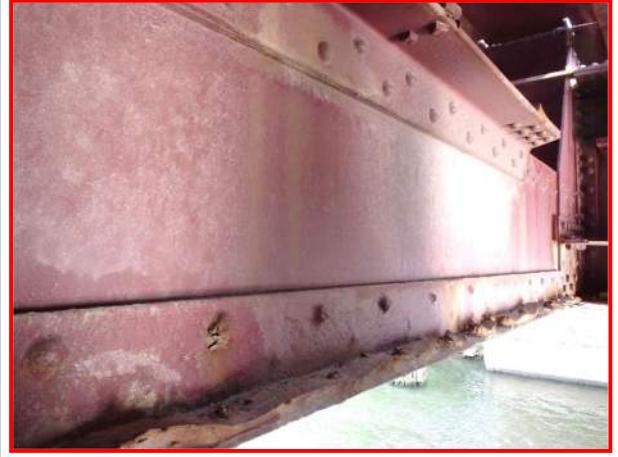
- Bottom chord members 0-2 and 2-4 of both leaves exhibit moderate to heavy corrosion and section loss of the bottom flange angles (see Photograph 46).
- The bottom chord gusset plates typically exhibit minor to moderate pitting that has been painted over, isolated areas of flaking paint with minor to moderate corrosion generally on the inside faces along the top of the bottom chord, and isolated areas of corrosion holes up to 2-inches in diameter (see Photograph 47).
- The bottom chord gusset plates have torch cut holes near the floorbeam- sidewalk bracket tie bar; no defects were noted.
- The following locations have minor to moderate bends in the plates:
 - PP10NE bottom edge of inside and outside gusset plate and there is a tear in the outside plates (see Photograph 48).
 - PP10SW bottom edge of inside and outside gusset plates.

46. Bottom Chord Member 0-2NW, looking northwest.

of missing secondary grid bars. Superstructure: see FC1 remarks for further information. Bottom Chord members 0-2 and 2-4 in all quadrants exhibit moderate to heavy corrosion and section loss of the bottom flange angles. Both gusset plates at PP10NE and

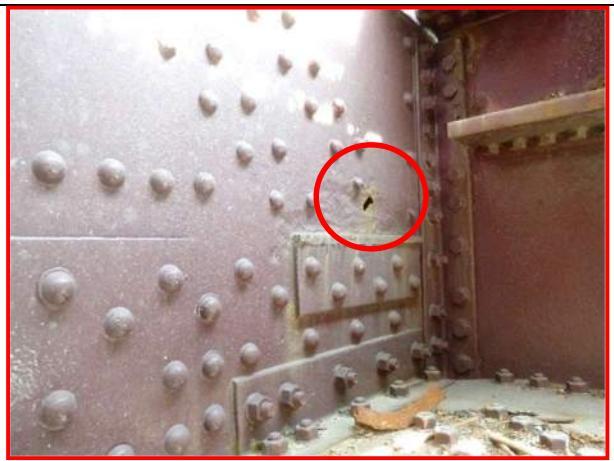
47. PP8NE Inside Gusset Plate, looking southeast.

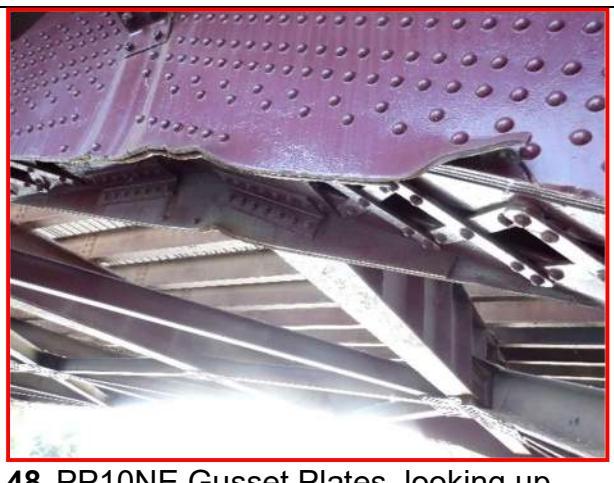
48. PP10NE Gusset Plates, looking up.

PP10SW exhibit damage and are bent, with PP10NE outside plate having a tear in this location. Substructure: The South Abutment

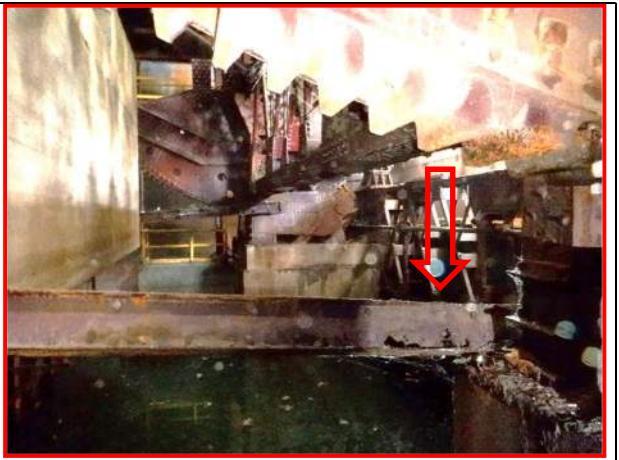
- The counterweights typically exhibit scattered cracks and surface spalls.
- The link members connecting the counterweights to the truss all exhibit moderate to heavy corrosion with corrosion holes and section loss; the Northwest Link is corroded through (see Photograph 49).
- The counterweight hangers attached to the truss and embedded in the counterweight concrete exhibit moderate to heavy corrosion at the concrete interface.

49. Northwest Counterweight Link, looking east.

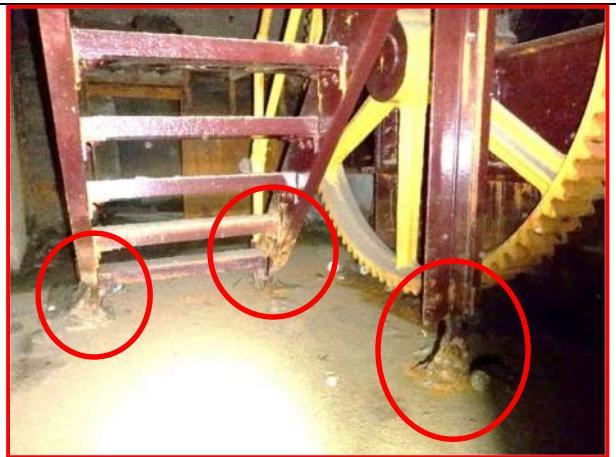
- North Bridge House:
 - The stairs that lead down to the machinery level have corrosion holes in the stringers at the base and there are large corrosion holes in the adjacent support column (see Photograph 50).
 - The elevated connection platform that goes over the west machinery has railing posts that are corroded through at the base and large corrosion holes in the support stringers (see Photograph 51).
 - Both suspended inspection platforms leading to the backwall are in working order at the time of inspection; however, there are several small diameter corrosion holes in the walking surface at the south end of the east platform.
 - The southwest outside face of the bridge house has a 3 SF spall with exposed reinforcement.
 - There are two red navigation lights mounted on the outside faces of the enclosure walls along the river; both lights were off during the time of inspection.

50.Northwest Machinery Level Stairs, looking north.

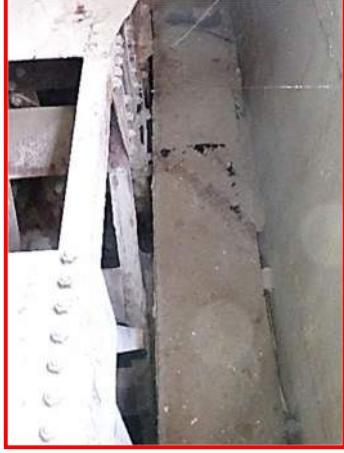
- The access catwalk along the back face of the river pier is heavily deteriorated (see Photograph 52).
- South Bridge House:
 - The last step in the stairs at the midplatform leading down to the machinery level is missing and the stringers have large corrosion holes.

52. North river pier catwalk, looking east.

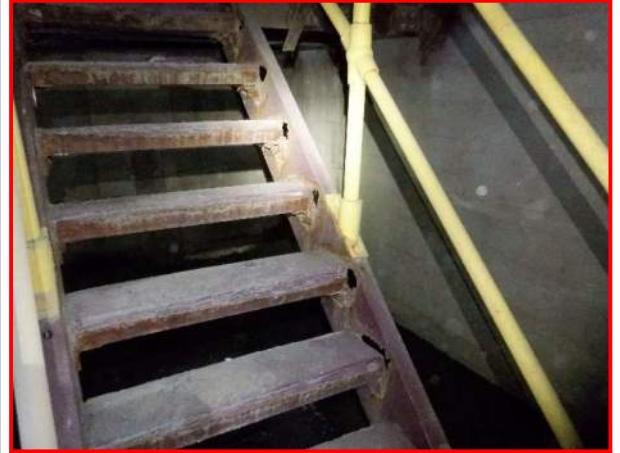
- The stairs that lead down to the machinery level have large corrosion holes in the stringers and the adjacent support column exhibits heavy corrosion and section loss (see Photograph 53).

53. Southeast Machinery Level Stairs, looking northeast.

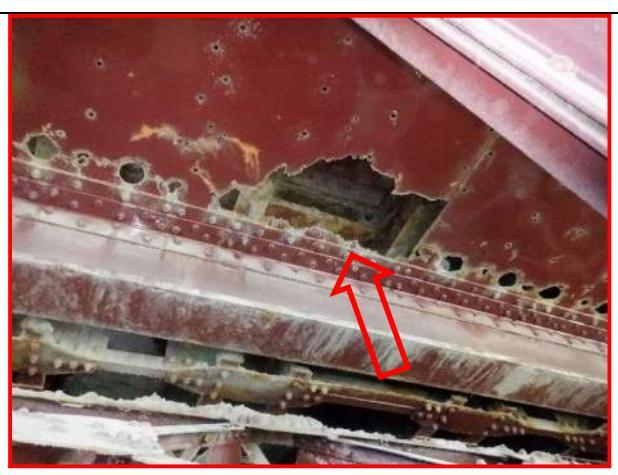
- The southeast truss guard has scattered corrosion holes.
- The horizontal steel plate between the top chord of Floorbeam 12-12 and the web of Floorbeam 16-16 exhibits scattered large corrosion holes with a loose section in the south plate (see Photograph 54).

54. North horizontal steel plate, looking up.

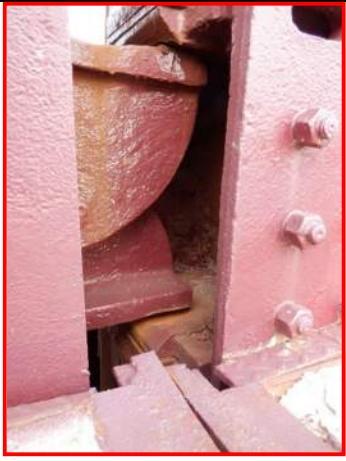
- The east and west center lock mechanisms are not engaged with a 1/2-inch gap creating noticeable vibration under live load (see Photograph 55).
- There are navigation lights in place at both fascias at the center break, and the missing one on the east side of the North Leaf was replaced prior to the current inspection. The lights were on at the time of inspection (see Photograph 56).
- At the center break, the southeast, southwest and northwest navigation light platform grates are loose.

55. West Center Lock, looking east.

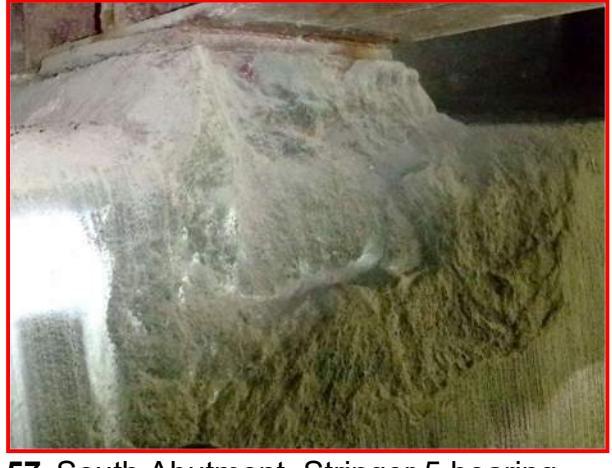
- The North Abutment and North Counterweight Pit back wall are one in the same. Comments for this element can be found in the Counterweight Pits section of this report.
- The South Abutment exhibits scattered hairline vertical cracking in the stem, wide horizontal cracks in the backwall, 80 SF of delamination in the stem below Stringer 7, and approximately 8 SF of edge spalling up to 2-inches deep along the bearing seats of Stringers 2 and 5 (see Photograph 57).

57. South Abutment, Stringer 5 bearing seat, looking southwest.

exhibits scattered hairline vertical cracking, delaminations up to 80 SF, and up to 2-inch deep edge spalls along the bearing seats of

Stringers 2 and 5. The trunnion posts exhibit minor to moderate corrosion.

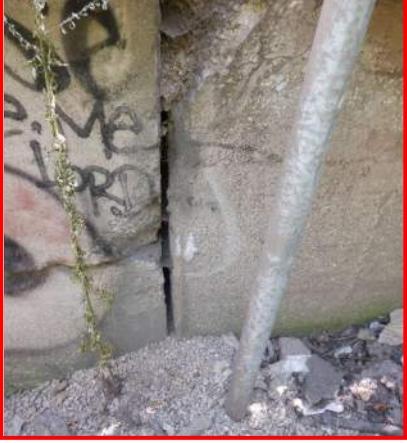
- The West Wingwall has narrow map cracks, spalls in the coping up to 3 SF, and a 3 SF spall at the south end with a minor amount of soil spilling through the vertical joint (see Photograph 58).
- The East Wingwall is buried and not visible for inspection.

58. West Wingwall end, looking east.

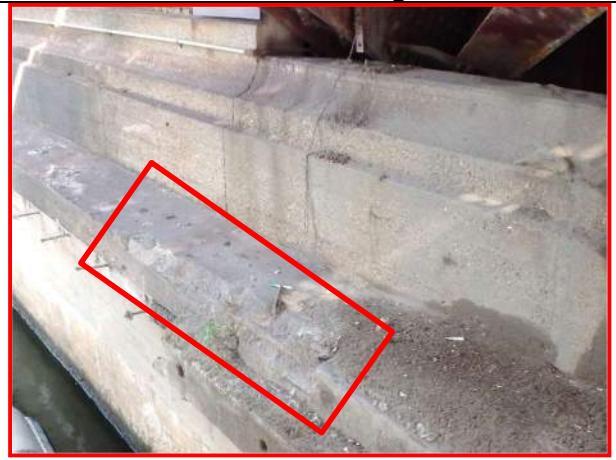
- The river piers exhibit moderate to heavy scaling along the waterline with up to 5-inches of penetration and there is debris buildup along the face and cap.
- The South River Pier has an 8 SF spall below the East Truss and there is a wide vertical crack near midspan (see Photograph 59).
- The North River Pier exhibits a 6-foot long by 1.5-foot wide edge spall with up to 4-inches of penetration and one exposed and corroded reinforcing bar near the West Truss (see Photograph 60).

60. North River Pier, looking northwest.

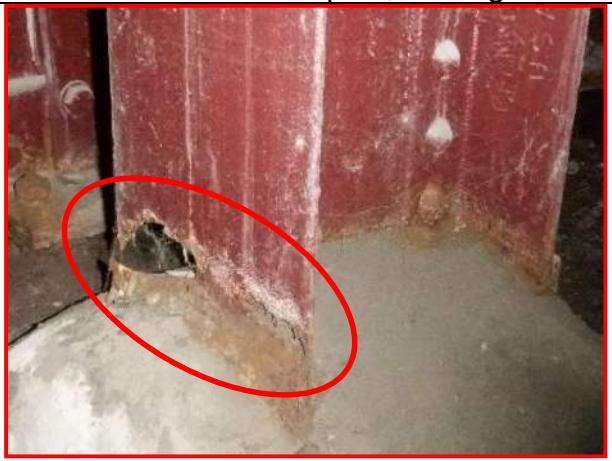
- The partially encased trunnion posts typically exhibit minor to moderate corrosion with minor flaking along the base and several corroded through lacing bars in the lateral supports (see Photograph 61).
- The A-frame supports for the outside trunnion posts exhibit minor corrosion and flaking predominantly at the bases.
- The sidewalk columns in the fixed spans exhibit minor to moderate corrosion and section loss with corrosion holes up to almost the full flange width at the bases. Many of them have welded web plate repairs (see Photograph 62).

62. Southwest Sidewalk Column, looking northeast.

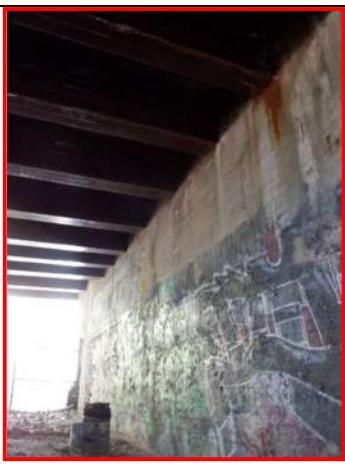
- The pit face of the counterweight pit backwalls under the sidewalks and below the counterweight are the only visible portions of the walls due to the position of the counterweight. The visible portions exhibit scattered hairline vertical and horizontal cracks with efflorescence and isolated delaminations and spalls up to 2 SF.
- The south face of the South Counterweight Pit Backwall exhibits corrosion stains, several scattered areas of delamination up to 4 SF and hairline to narrow radial cracks emanating from the embedded stringers (see Photograph 63).

63. South Counterweight Pit Backwall, South Face, looking northwest.

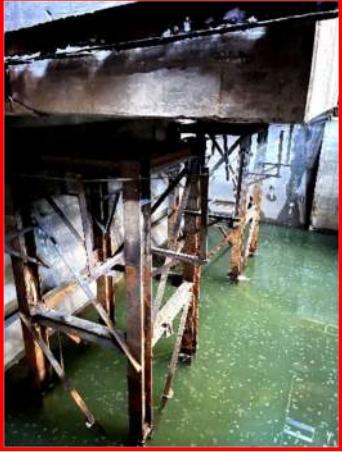
- The east and west pit walls exhibit hairline to narrow leaching vertical and horizontal cracks.
- Both counterweight pits have shoring towers, but they are not supporting the counterweight (see Photograph 64).
- Both pits have minor debris; the North Counterweight Pit has approximately 12-feet of standing water and the South Counterweight Pit has approximately 3-feet of standing water.

64. South Counterweight Pit shoring, looking southwest.

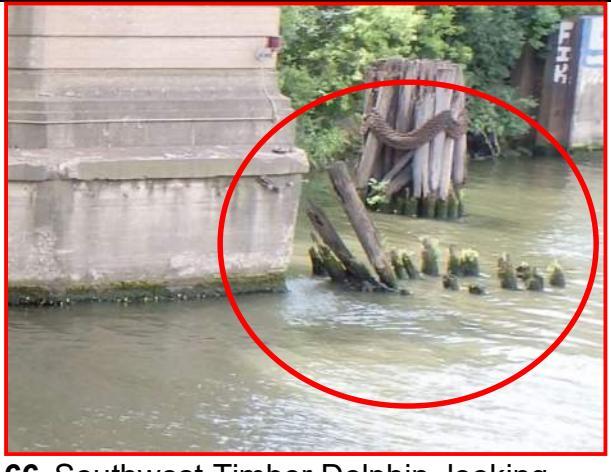
- The timber fenders exhibit minor to moderate deterioration with large missing sections at both ends of the river piers (see Photograph 65).
- There are timber dolphins in place at all corners of the structure, and all exhibit broken piles and moderate to heavy deterioration around the waterline.
- The southwest timber dolphin has failed (see Photograph 66).

66. Southwest Timber Dolphin, looking southwest.

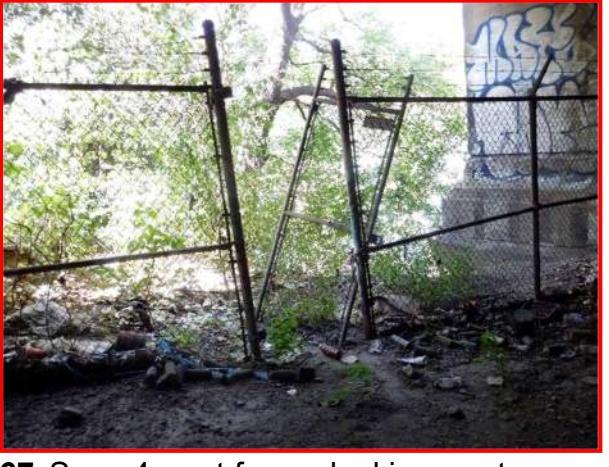
- The east and west fences in Span 4 have been cut/gates broken allowing unauthorized access (see Photograph 67).
- There is graffiti on the outside of the bridge house walls and on the South Abutment.

67. Span 4 west fence, looking west.

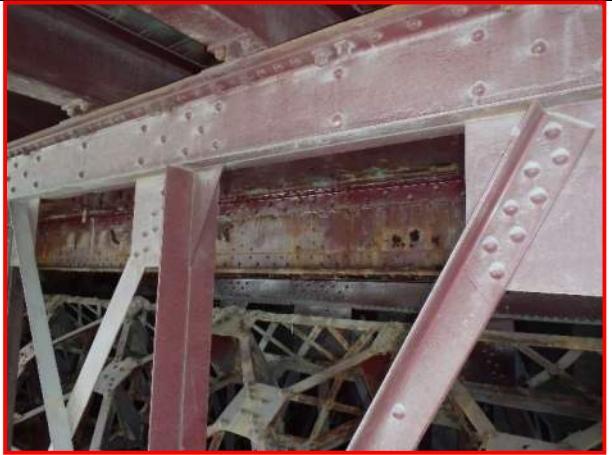
• On a scale of 5 to 1 (5 being new; 1 being failed), the paint system for this structure is rated a 3 (fair).

• The protective coating exhibits random areas of flaking paint and the exposed steel has varying degrees of corrosion (see Photograph 68).

68. Superstructure protective coating, looking southeast.

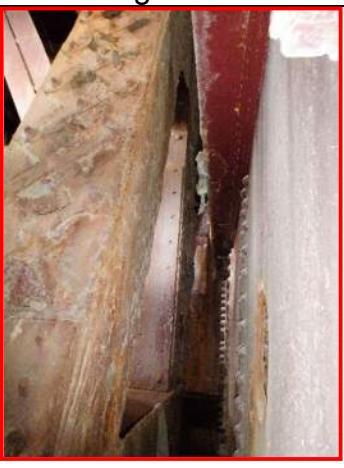
The protective coating typically exhibits paint fading except at the bottom 1' of columns and along the trunnion posts laterals where it has failed and led to heavy corrosion and section loss (see Photograph 69).

69. Substructure protective coating, looking south.
