California Avenue Bridge Over the Chicago Sanitary and Ship Canal ****

Appendix G: BRIDGE INSPECTION REPORT

Structure No. 016-6005

Inspection Date: August 3, 2022

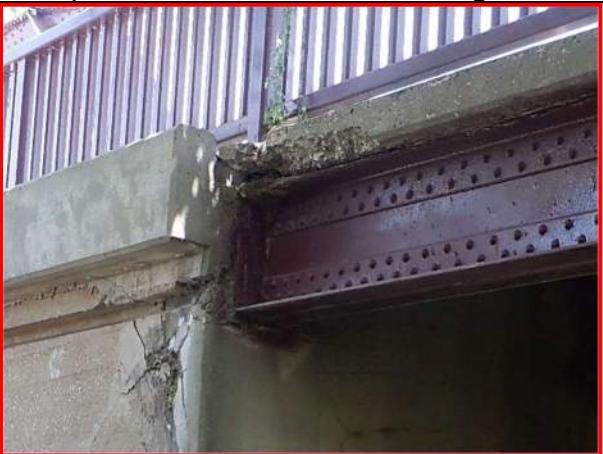
10. Span 4, West Sidewalk, looking northeast.

- The Fixed Span sidewalks exhibit scattered light scaling and debris along the edges.
- Span 3, the east sidewalk at the south counterweight pit back wall has an approximately 3-foot length of missing joint filler adjacent to the bridge railing and a 5-inch by 16-inch through hole adjacent to the curb (see Photograph 9).
- Span 4, there is a 3 SF spall in the edge of the west sidewalk near the south counterweight pit back wall (see Photograph 10).
- The underside of the sidewalks in the Fixed Spans exhibit a few scattered hairline diagonal and transverse cracks, areas of delamination up to 2 SF, and spalls up to 2 SF with corrosion staining at the embedded steel plates in Span 4.
- The navigation light platform hatches near the Center Break are all unsecured.
- The northeast approach sidewalk has a vertical settlement of up to 1-inch.

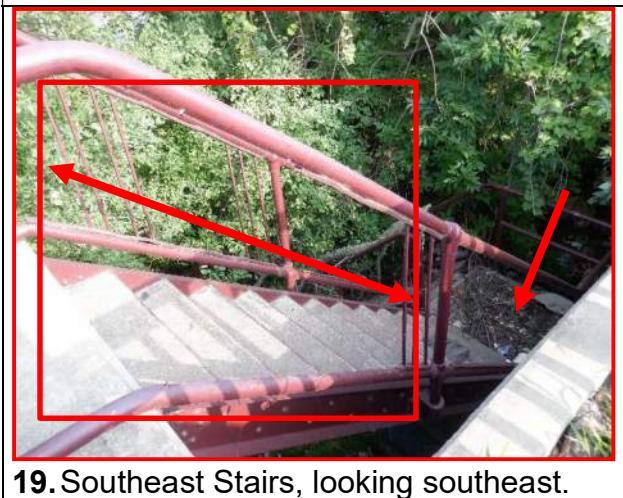
- Life preservers are in place at the northwest and southeast corners of the bridge and there is minor graffiti on the southeast live preserver box (see Photograph 18).
- The railings along the stairs in the southeast corner of the structure are missing most of the railing spindles (see Photograph 19).
- There is vegetation encroachment over both sidewalks in Span 4.

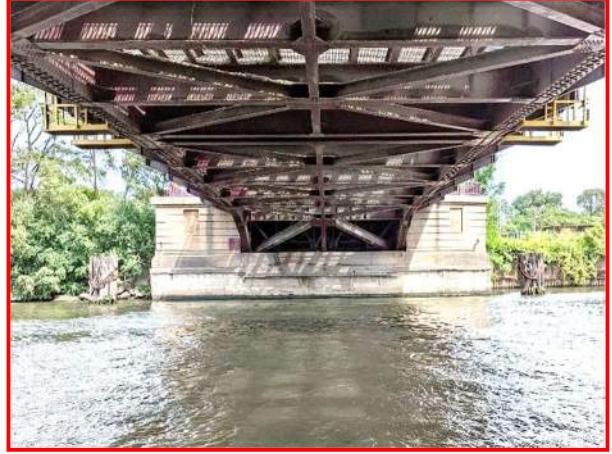
20.Overall underside of the movable span, looking north.

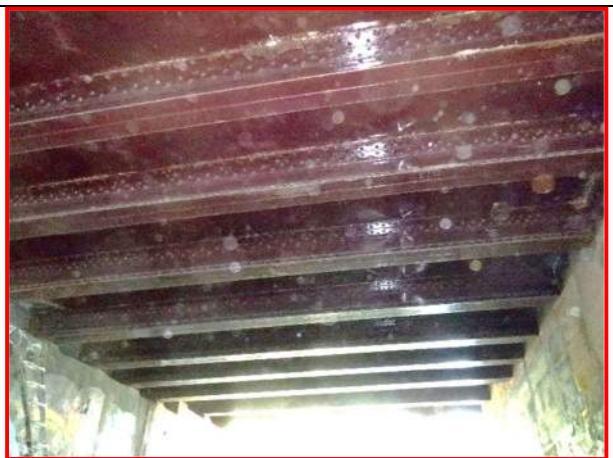
21. Overall underside of the fixed span, looking west.

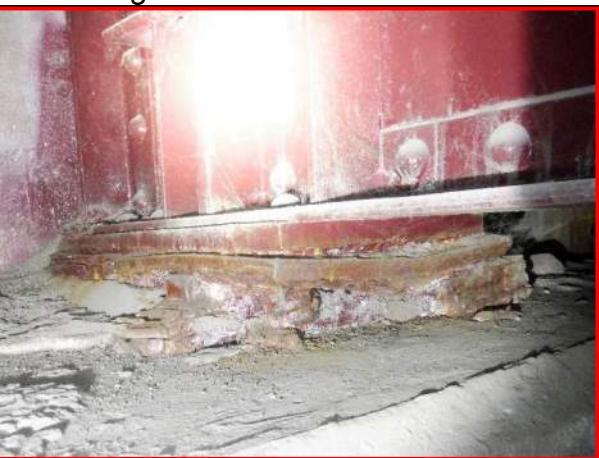
22. Span 1, west sidewalk stringer bearing, looking northeast.

- The bearings that support the roadway stringers at the backwall of the counterweight pit in Spans 1 and 3 are inaccessible for inspection due to the position of the counterweight.
- The sidewalk stringer bearings in the fixed spans typically exhibit minor to moderate corrosion; Span 1, the west sidewalk stringer bearing exhibits moderate corrosion with moderate section loss and approximately 15% bearing area loss (see Photograph 22).
- The bearings on the South Abutment exhibit minor corrosion and the elastomers are slightly deformed out-of-plane; Stringer 2 and Stringer 5 exhibit 2-inches of bearing area loss along the full width at the face of the abutment (see Photograph 23).

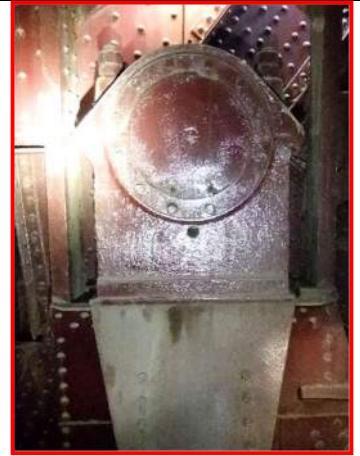
25. Northwest Trunnion Bearing, looking east.

- The live load bearings exhibit minor surface corrosion with minor pitting (see Photograph 24).
- The trunnion bearings typically exhibit minor pitting that has been painted over (see Photograph 25).
- The secondary live load bearings exhibit moderate to heavy corrosion with minor pitting and pack rust between the strike plates (see Photograph 26). There is no gap at any of these bearings.

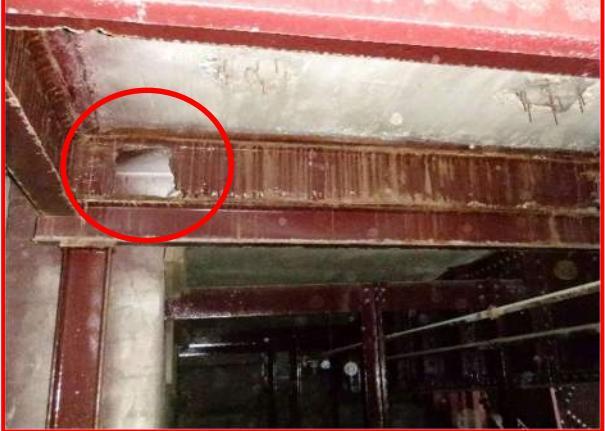
38. Span 3, east sidewalk floorbeam, looking south.

- Several fixed span sidewalk floorbeams exhibit full depth corrosion holes in the web; however, there are additional repair members in place below (see Photograph 38).

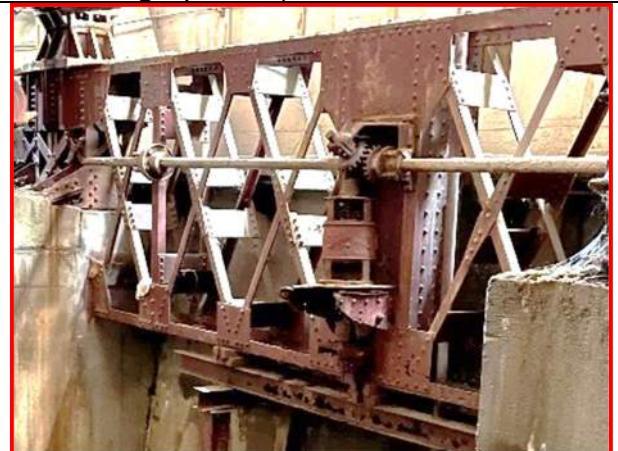
41.Span 3, south live load bearing support truss, looking northwest.

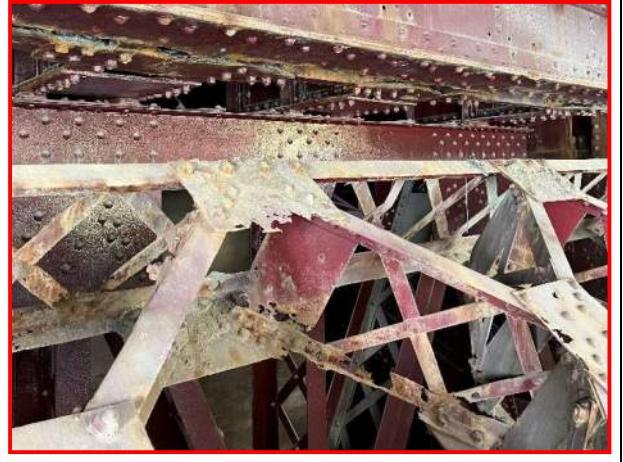
42.Span 3, south lattice truss, looking southwest.

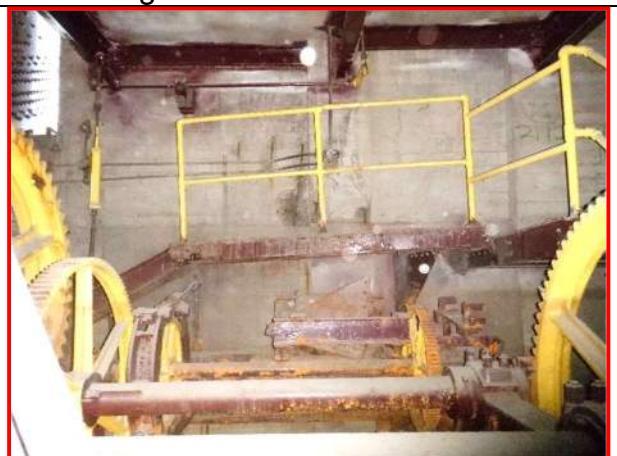
51.Northwest Elevated Connection Platform, looking south.

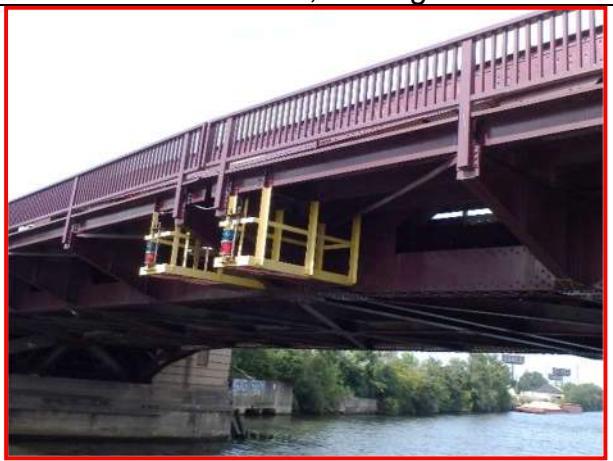
56. East Center Break Navigation Lights, looking southwest.

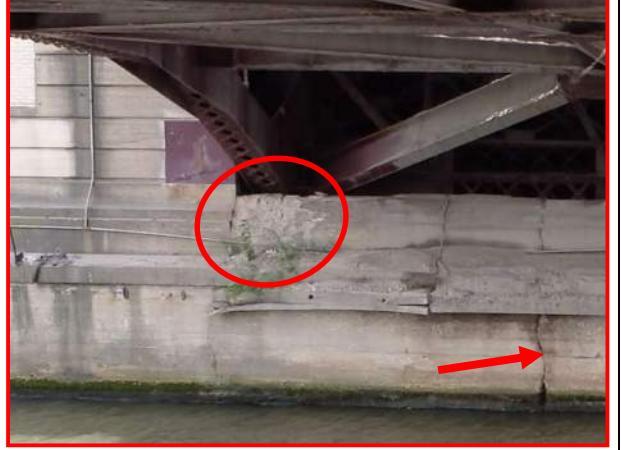
59. South River Pier, looking south.

- The river piers exhibit moderate to heavy scaling along the waterline with up to 5-inches of penetration and there is debris buildup along the face and cap.
- The South River Pier has an 8 SF spall below the East Truss and there is a wide vertical crack near midspan (see Photograph 59).
- The North River Pier exhibits a 6-foot long by 1.5-foot wide edge spall with up to 4-inches of penetration and one exposed and corroded reinforcing bar near the West Truss (see Photograph 60).

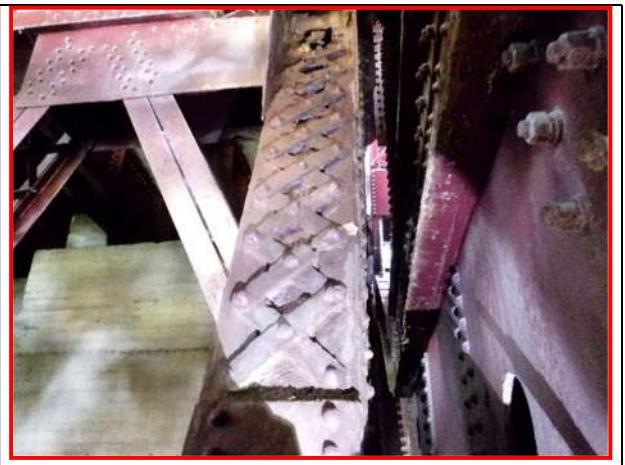
61. Northeast trunnion post, looking north.

- The partially encased trunnion posts typically exhibit minor to moderate corrosion with minor flaking along the base and several corroded through lacing bars in the lateral supports (see Photograph 61).
- The A-frame supports for the outside trunnion posts exhibit minor corrosion and flaking predominantly at the bases.
- The sidewalk columns in the fixed spans exhibit minor to moderate corrosion and section loss with corrosion holes up to almost the full flange width at the bases. Many of them have welded web plate repairs (see Photograph 62).

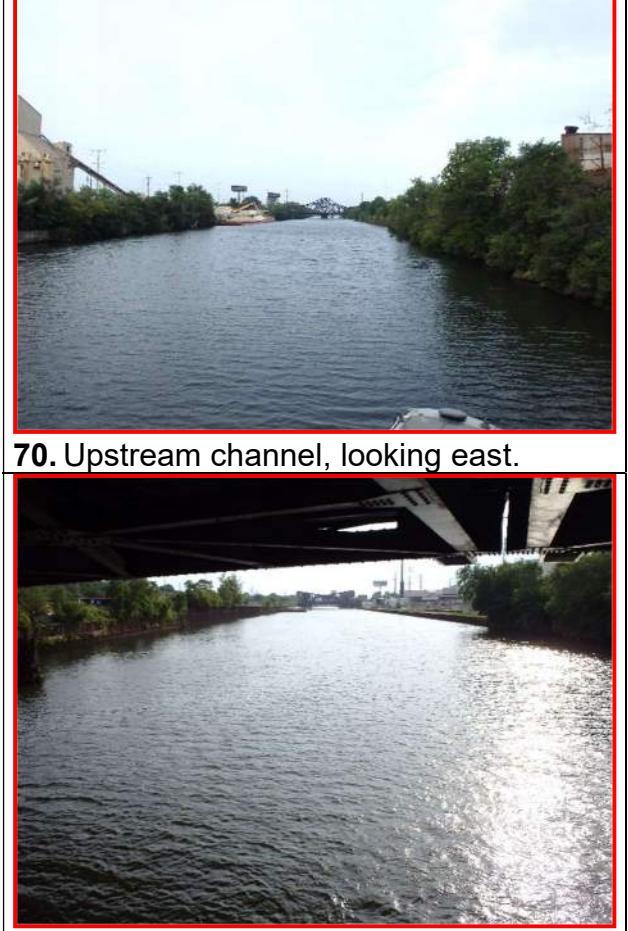
71. Downstream channel, looking west.
